**Subsidence Documentation Study**  
**Sufco Mine**  
**May 30, 2003**  
**Summary**

The data contained in this binder is a compilation of subsidence features gathered in the field from the 19 of May to the 22 of May 2003. The features have been organized into five different sections representing panels in descending order starting with the most recent. At the beginning of each section is a summary sheet outlining important aspects of the panel with emphasis on subsidence features contained therein.

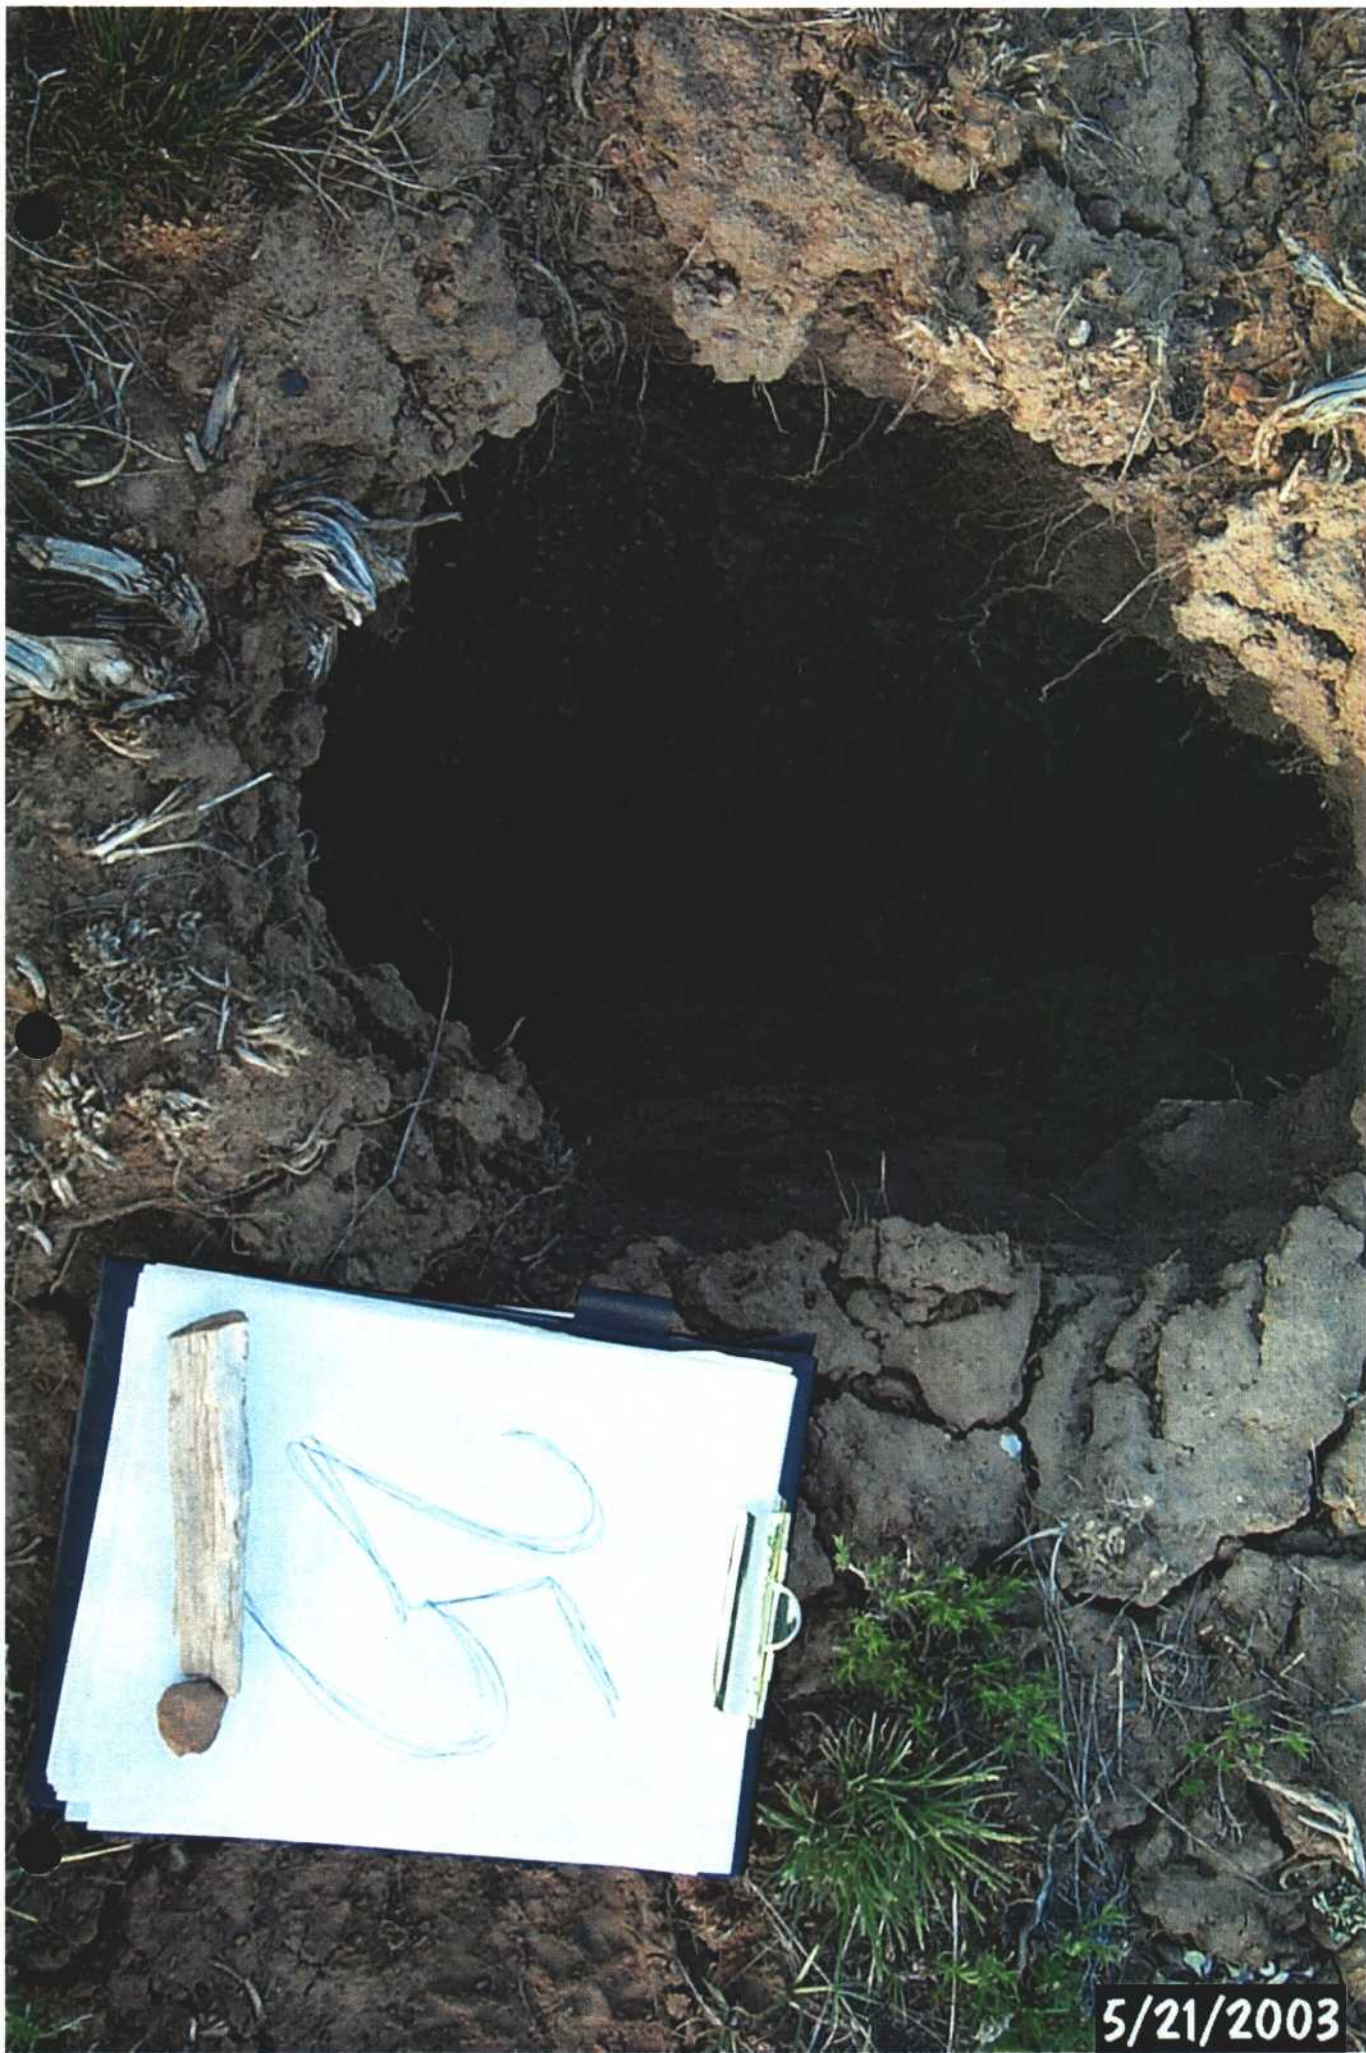
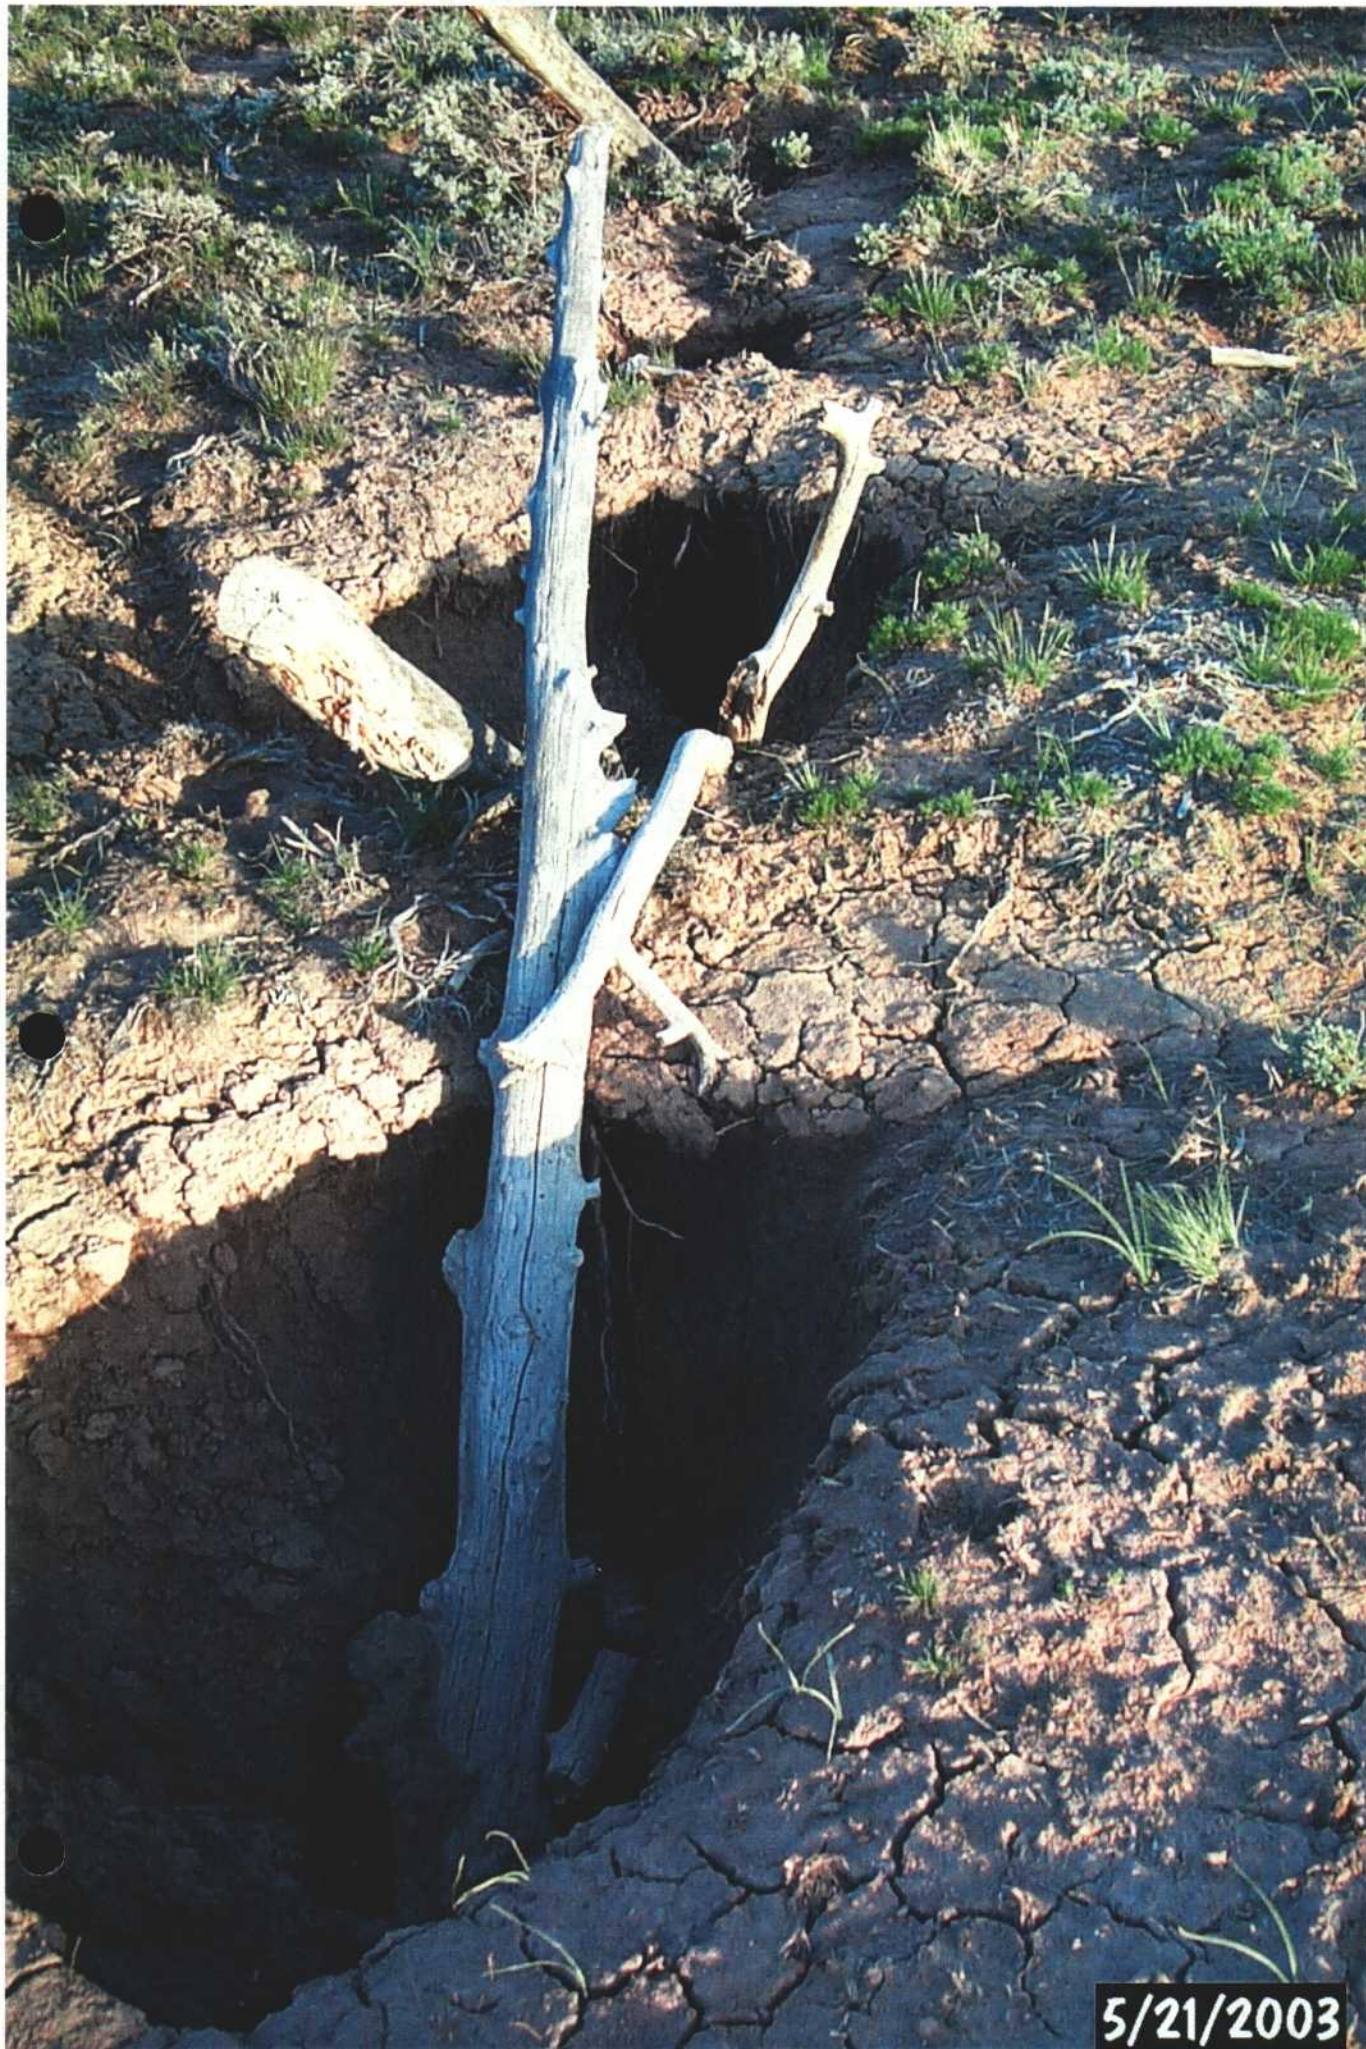
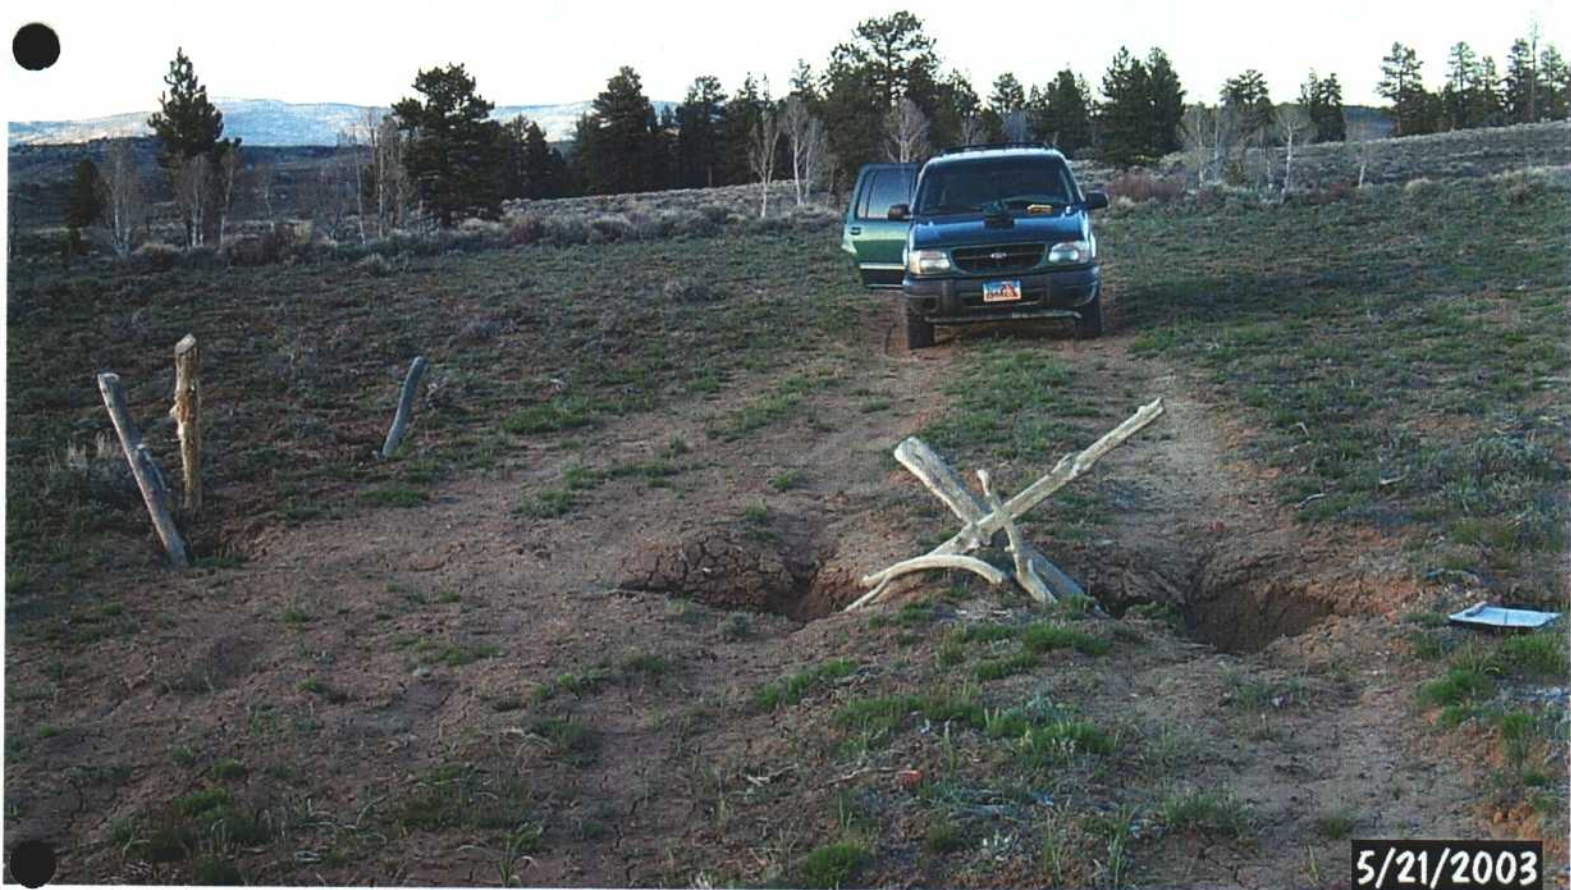
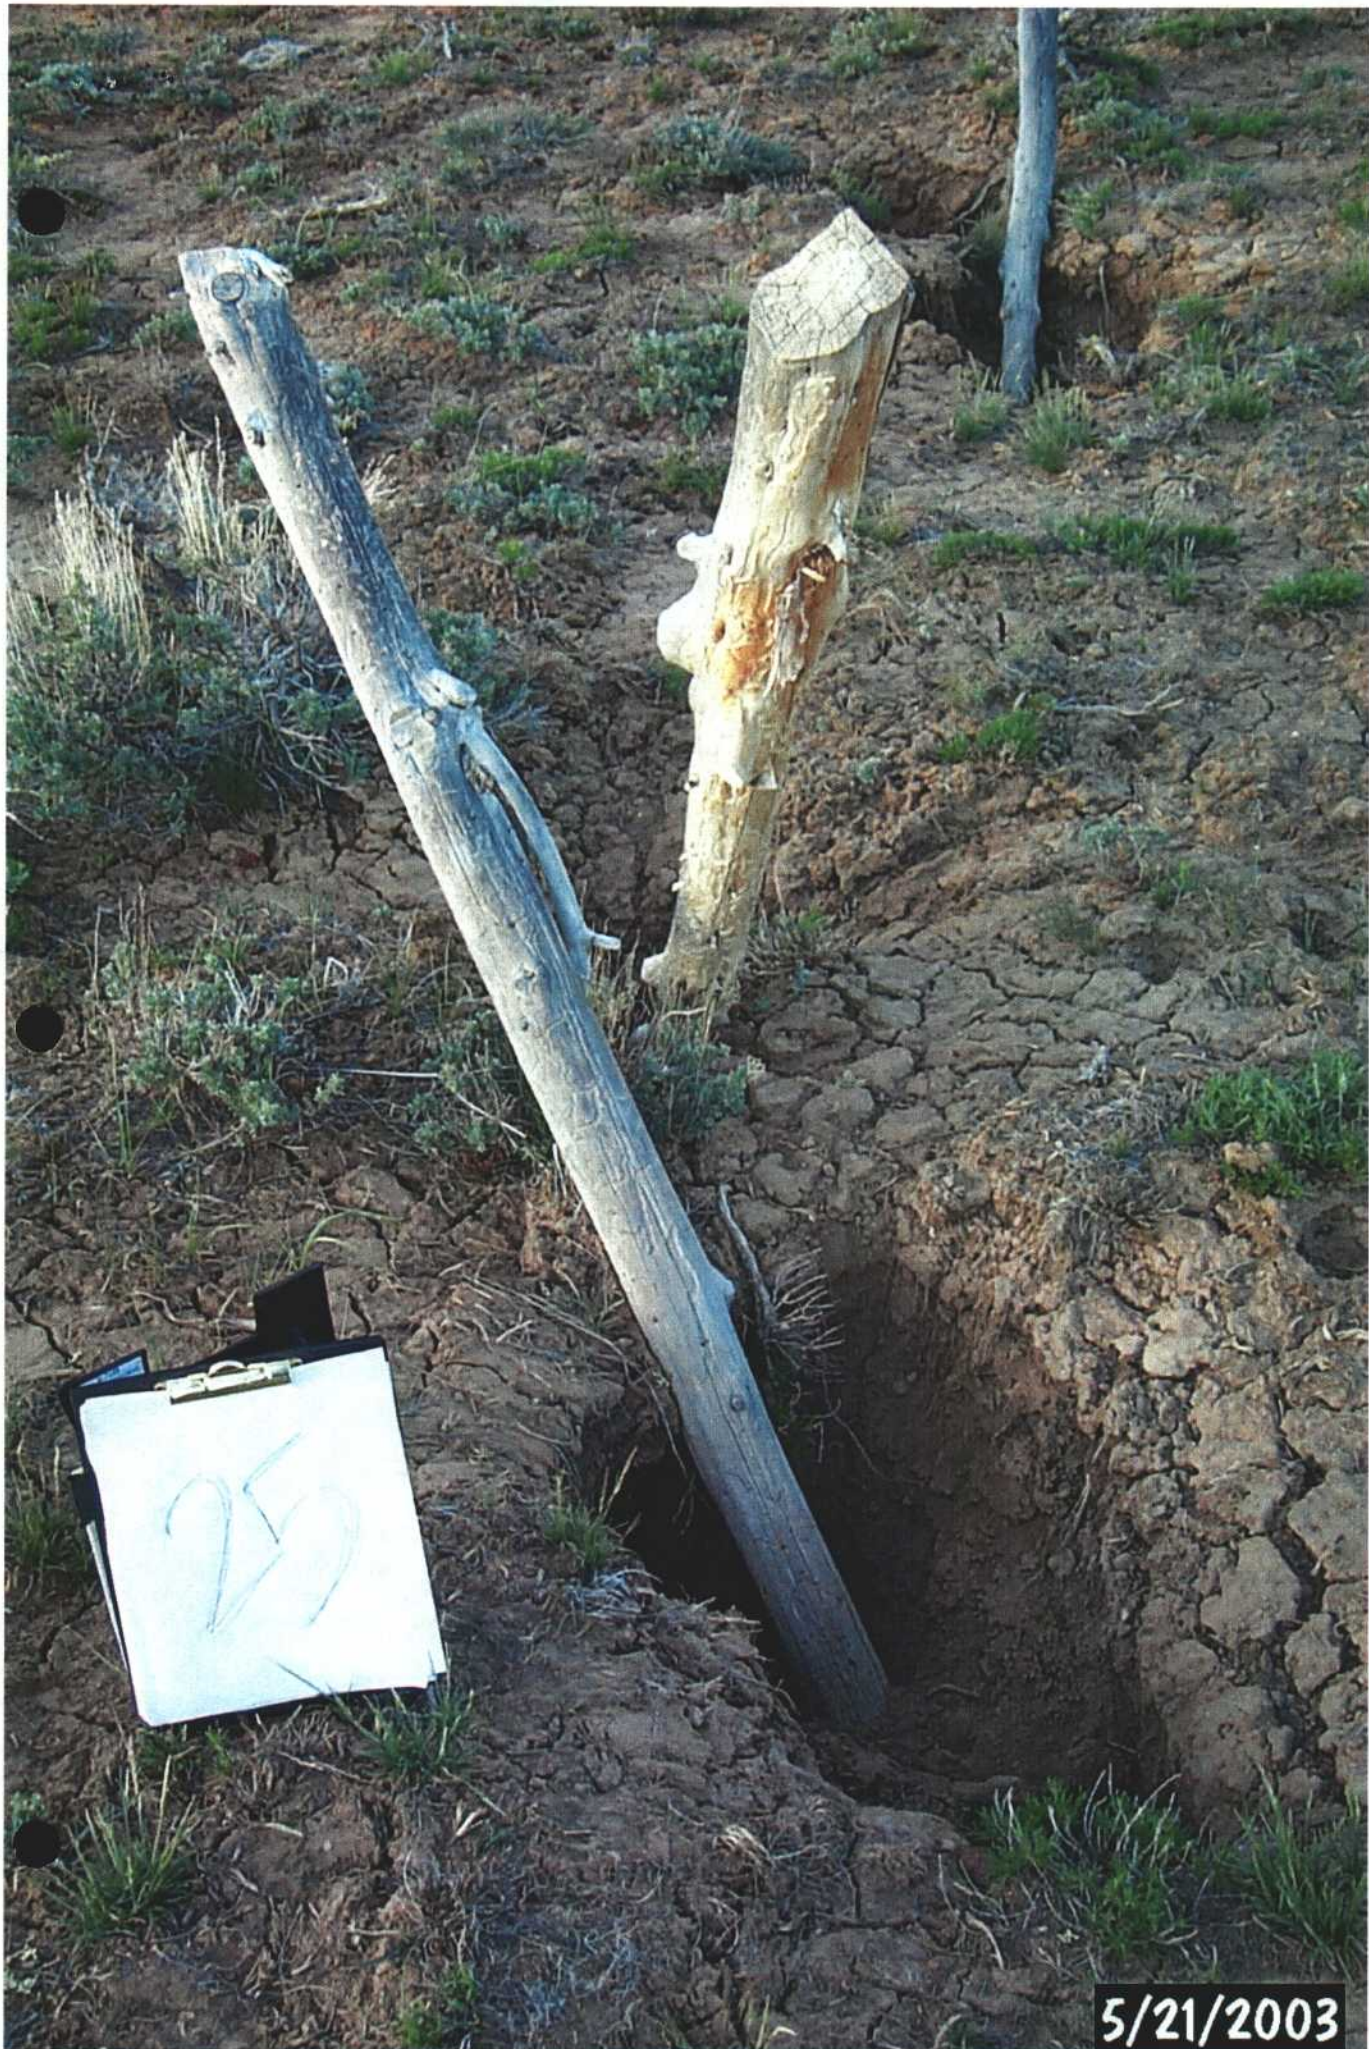
**Dimensions (in feet):** This crack is 230 feet long, up to four feet wide, and appears very deep.

**Potential Hazards?** Possible hazards to cattle, hikers, summer interns, semis, etc. Cuts through a road, so it's possibly a hazard to anyone daring enough to drive over it (see photos).

There is some healing along its length, however mining occurred here over ten years ago. I would recommend at least mitigating the part that runs through the road.

Feature 33 should definitely be considered for mitigation. The area wherein this feature lies was undercut eleven years ago, and has had little success in healing on its own. This feature demonstrates potential hazards to cattle and those intrepid enough to cross it in a vehicle.

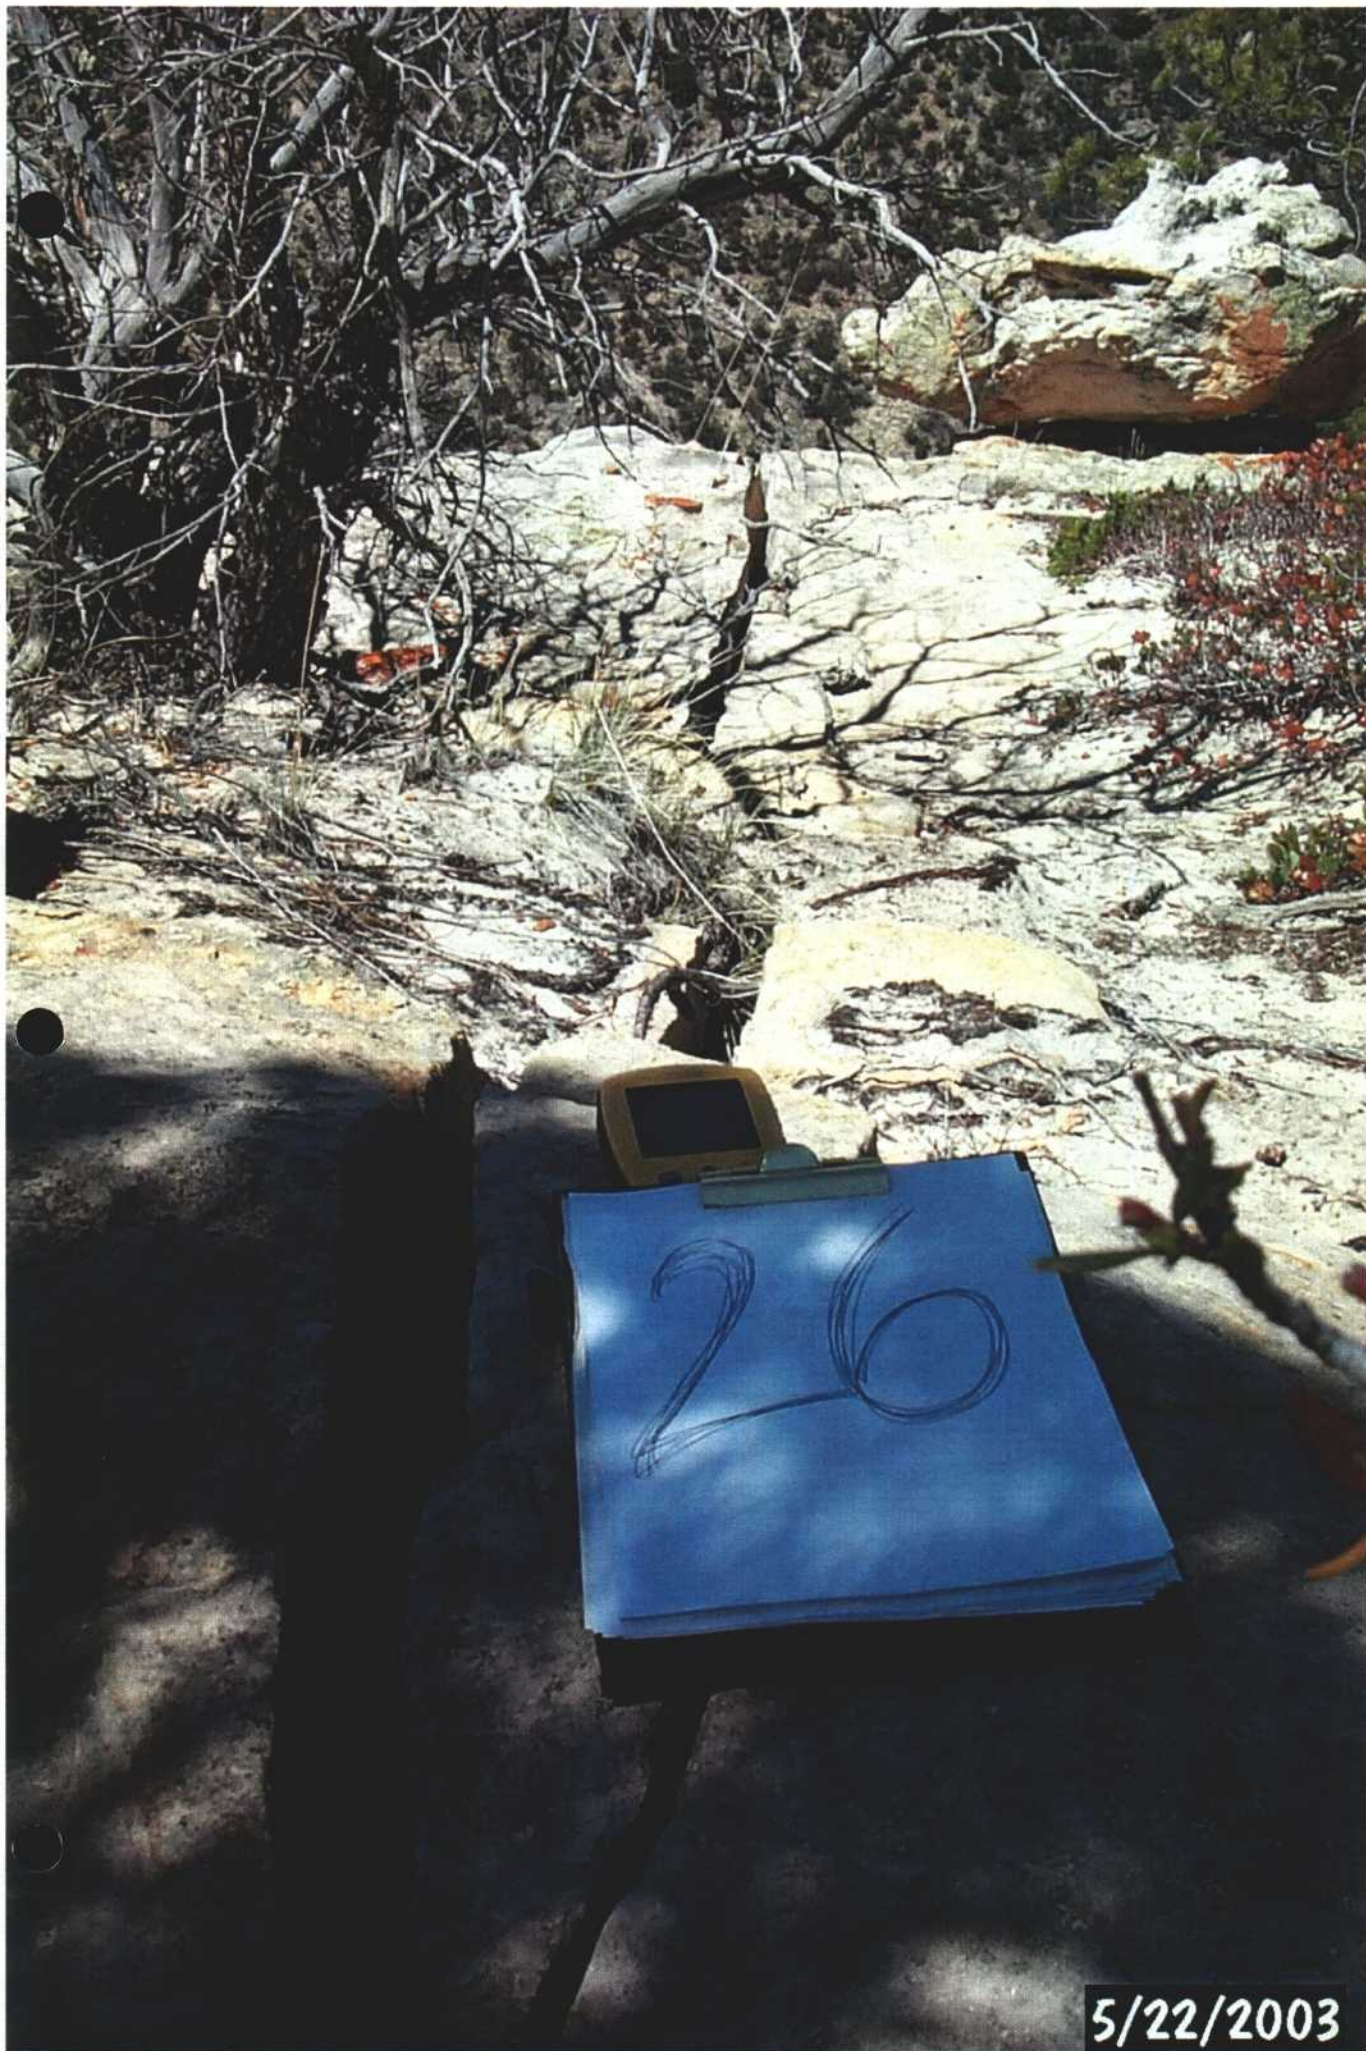
**Dimensions (in feet):** This crack is 28 feet long, and up to four inches wide.

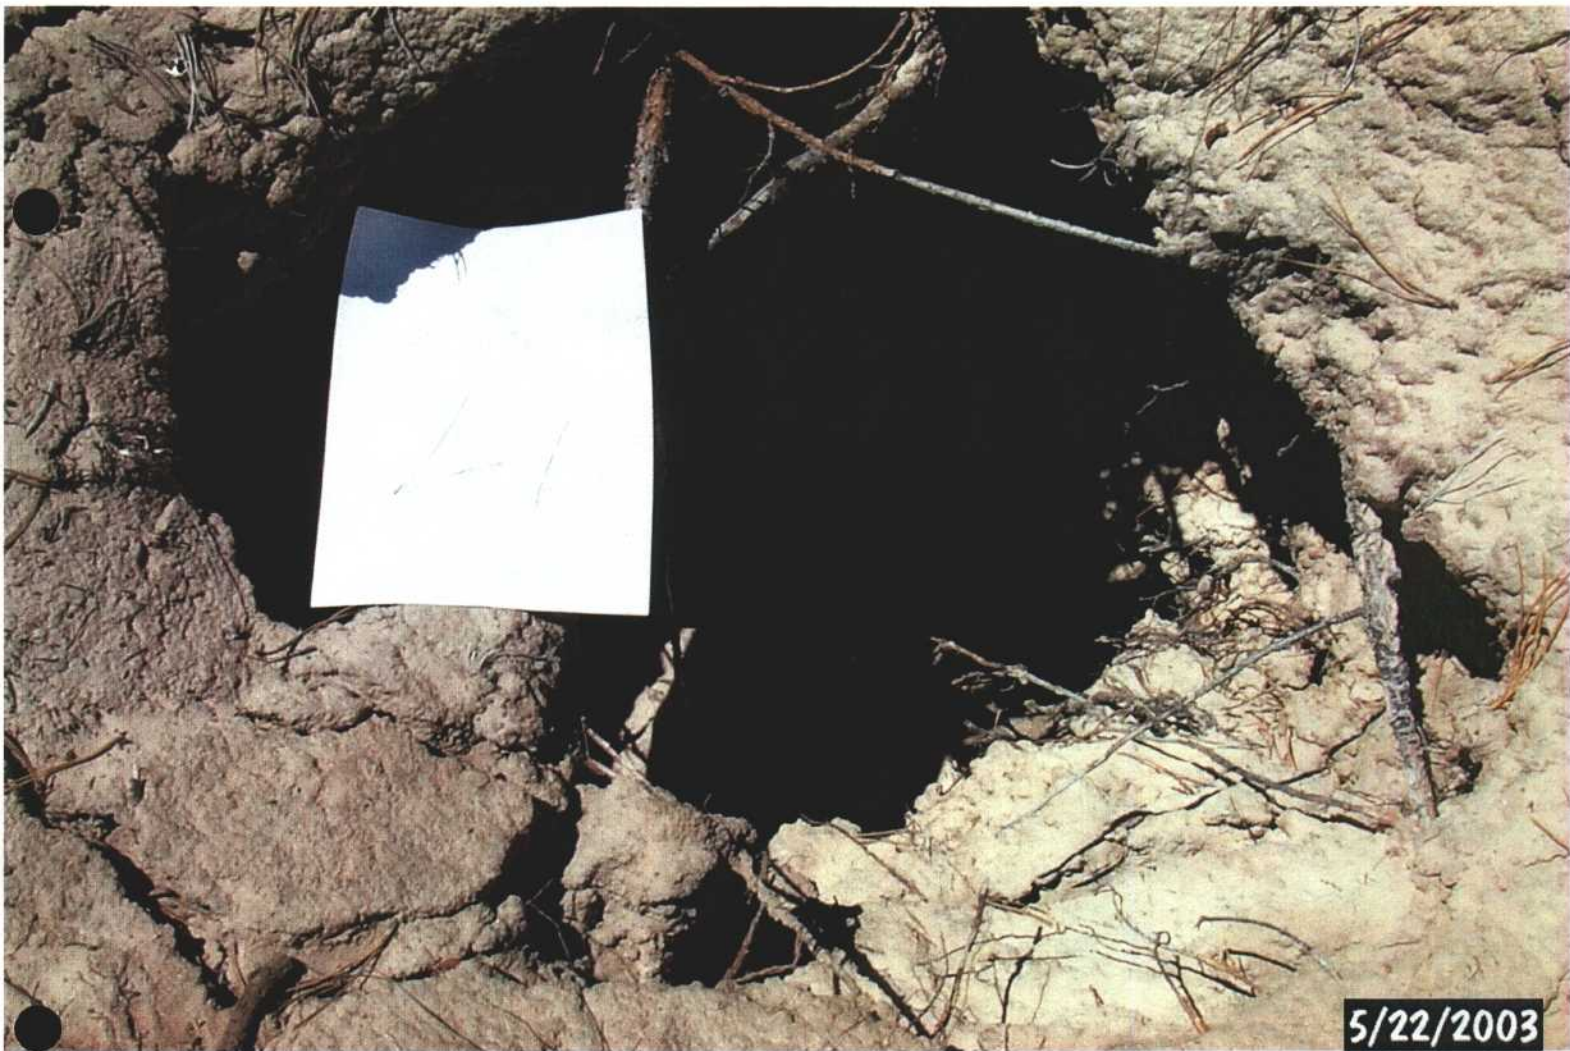
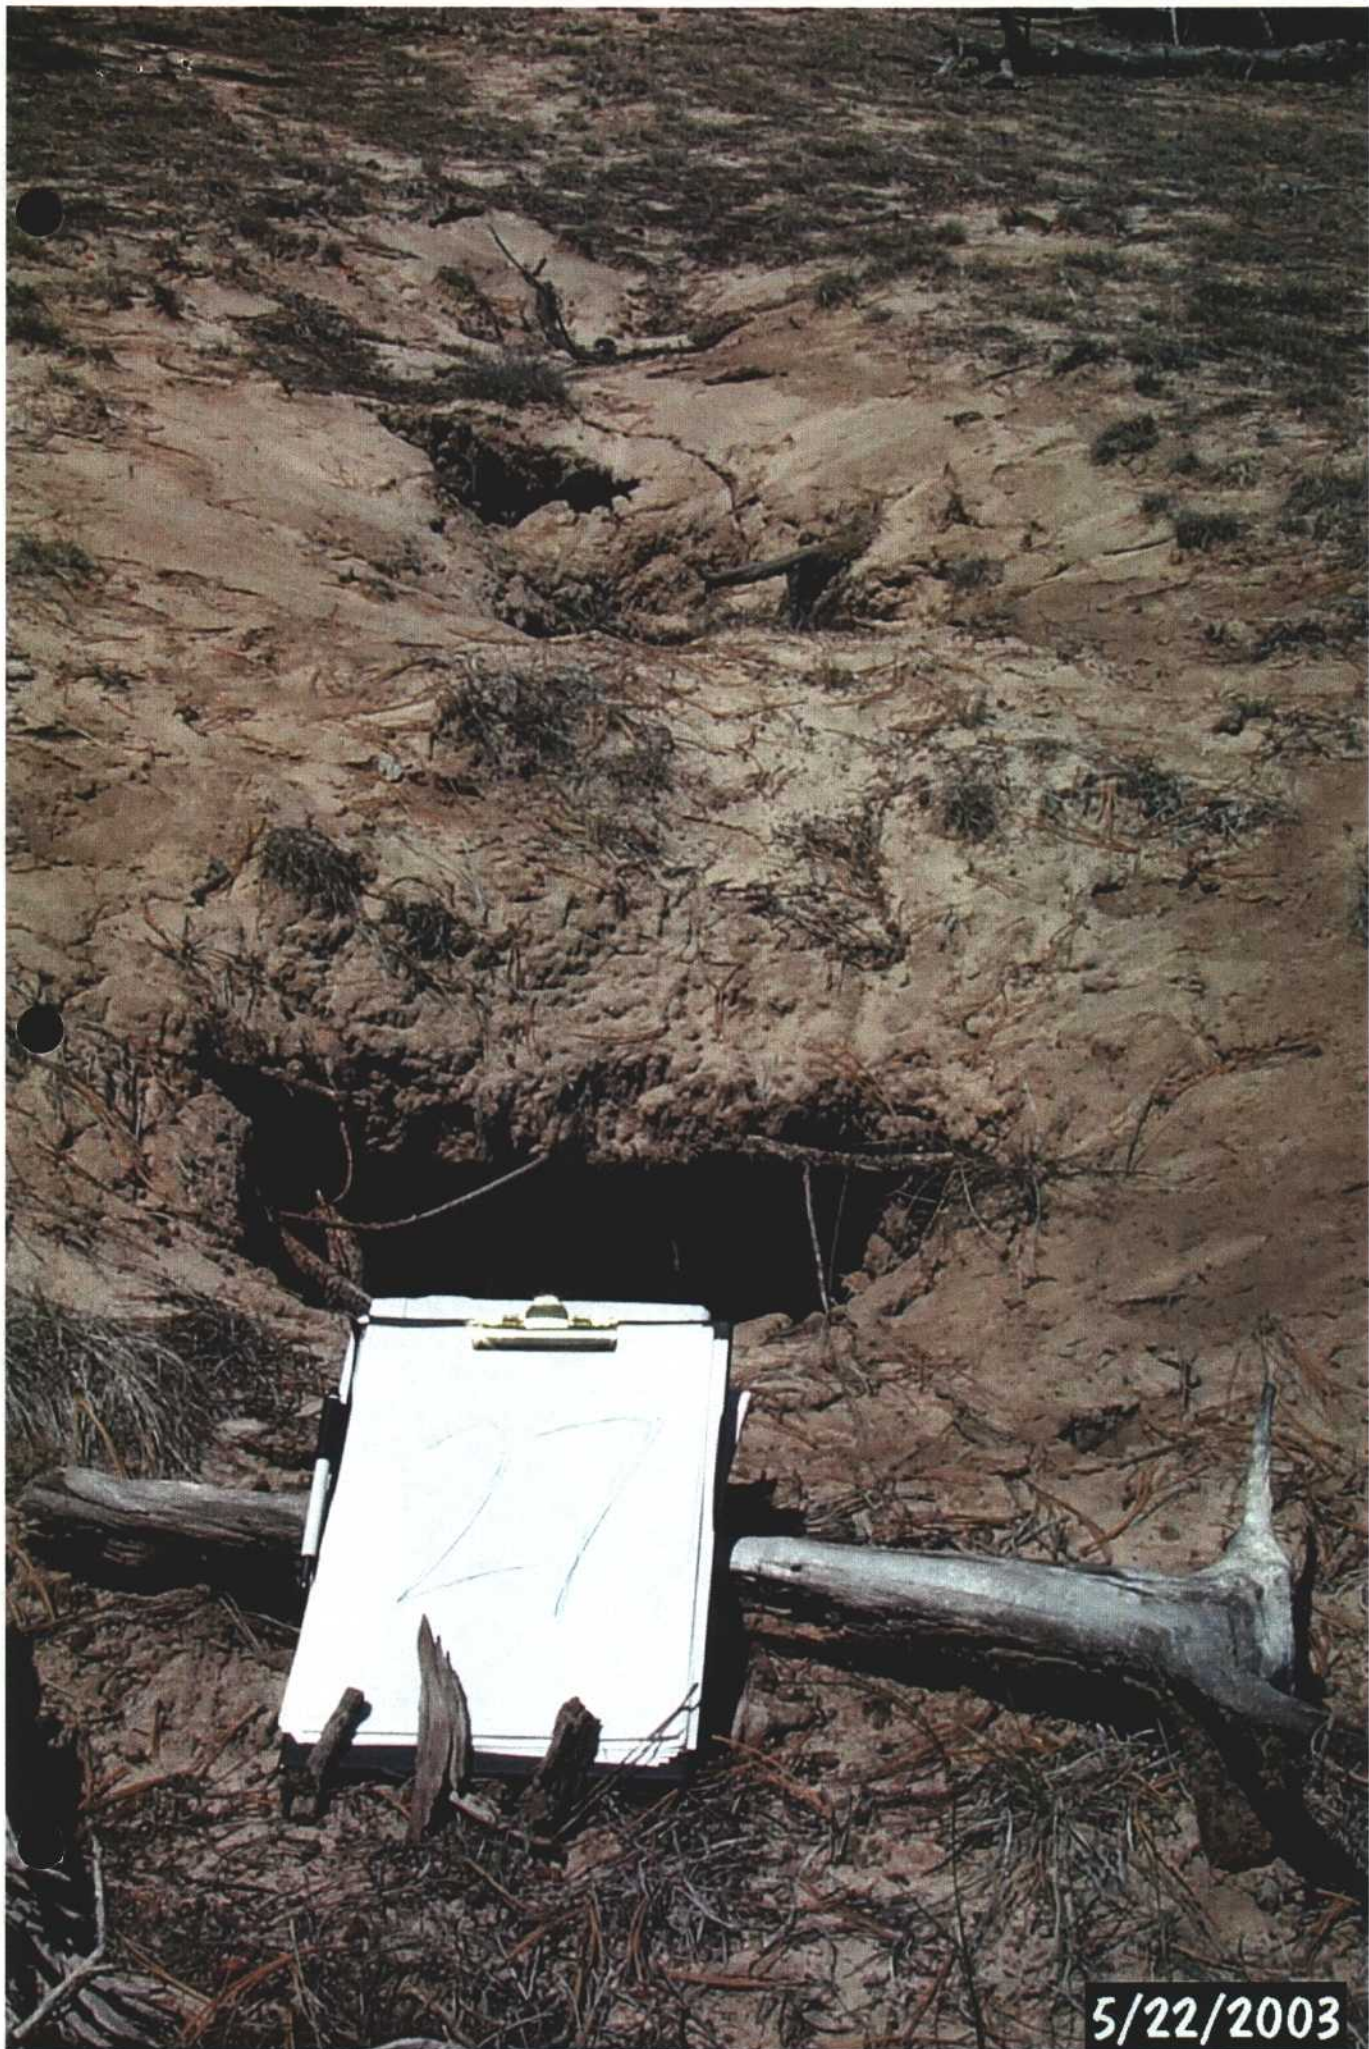
Dimensions (in feet): This is a series of sinkholes all in a row which suggests that this may have been a crack at one time but has not fully healed. The sinkholes all average about 30 inches in diameter, spaced about 2 feet apart.

Potential Hazards? In this case it is difficult to justify mitigation because the area doesn't appear to be frequented by cattle, and it is quite remote and away from any roads. Notwithstanding, the holes are quite deep.

These sinkholes occur on the crest of a ravine, which unlike a stream channel does not receive a steady stream of sediment flowing across its length. Under these conditions, it could be a very long time before these sinkholes fill up completely.
